Human body stability in floodwaters: The 2011 flood in Brisbane CBD.  
In Chanson, H & Toombes, L (Eds.) *Hydraulic Structures and Society - Engineering Challenges and Extremes: Proceedings of the 5th IAHR International Symposium on Hydraulic Structures (ISHS2014)*.  
The University of Queensland, Australia, pp. 1-9.

## Human body stability in floodwaters: the 2011 flood in Brisbane CBD

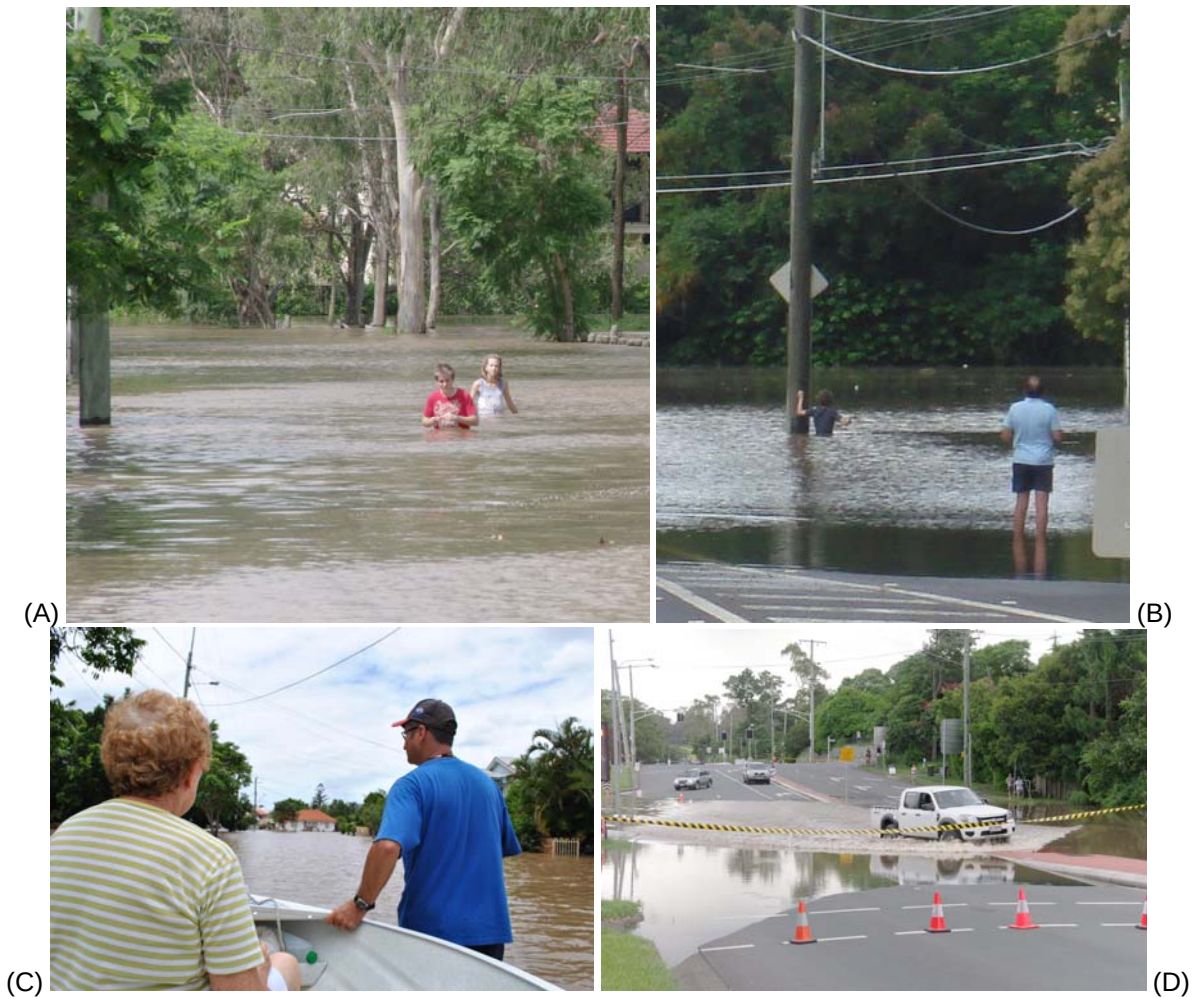
Figure 1 – People in floodwaters during the 2011 Brisbane River flood (Australia) - (A) Indooroopilly Road on 12/1/2011 afternoon about 14:50; (B) Indooroopilly Rd on 12/1/2011 morning (Courtesy of K. Clarke); (C) Chelmer Street East on 13/1/2011 at 11:34 (Courtesy of F. Reid); (D) Moggill Road on 12/1/2011 about 17:00

On 12-14 January 2011, the City of Brisbane was affected by a major flood causing over \$500 millions of damage (Fig. 1). During the event, some field measurements were conducted in an inundated street of the central business district (CBD) (Brown and Chanson 2013). The results are re-analysed herein with a focus on the flow turbulence and the implication in terms of human body stability in floodwaters in an inundated urban setting. It is the purpose of this contribution to discuss the current recommendations on human body stability and their relevance in the context of the January 2011 flood in Brisbane, based upon the field experience and detailed measurements during the event.

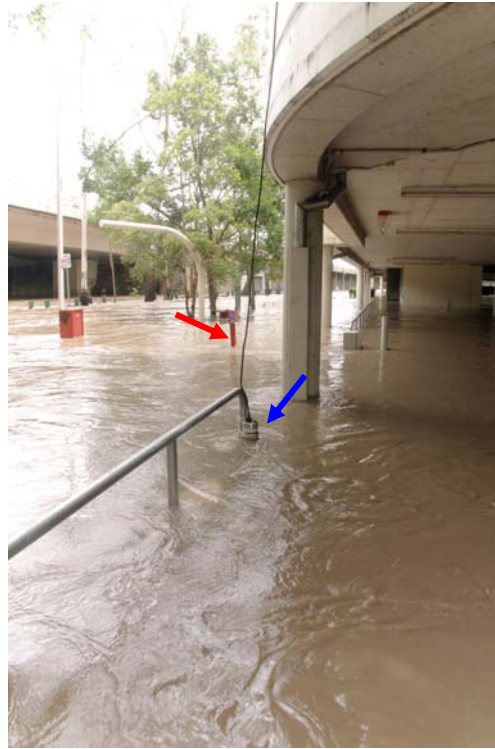
Figure 3 – Gardens Point Road (Brisbane CBD, Australia) on 13/1/2011 at about 11:00. Looking upstream at ADV sampling sites (T2: Red arrow; T4-T5: Blue arrow) - The water depth in the foreground was about 1 m

During the rising stage of the flood, the river swelled and inundated Gardens Point Road and the surrounding car parks. A relatively fast flow motion was observed along Gardens Point Road from Parliament House to the Goodwill Bridge. The river surface was brown and the waters were heavily sediment-laden. The river started to recede on 13 January morning, and it left a 2-10 cm thick layer of soft mud on Gardens Point Road and the car parks on 14 January 2011 morning.
